Manhole Inspection Summary

Manhole # S49A__035MH

Inspection ☐ Is Incomplete Rating: **5) Immediate Attention Required**

Location Address: **front corner 401 n lakewood av** Cross Street: **orleans st**

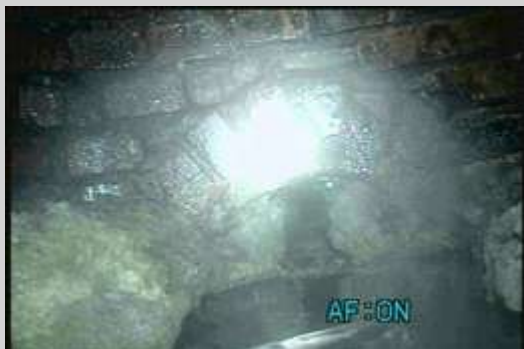
6 O'Clock Inflow

cant see in 6 to much build up

Deposits: ☐ None ☐ Mud ☐ Sludge ☐ **Debris** ☒ **Grease**

Silt Depth: 0 (in.) Deposits Extent: **Heavy**

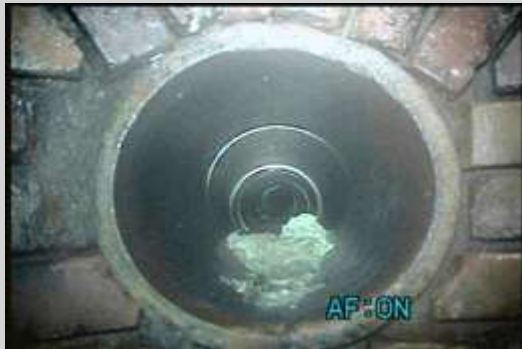
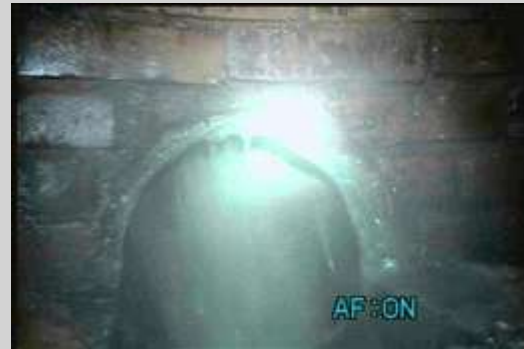
9 O'Clock Inflow

Deposits: ☐ None ☐ Mud ☐ Sludge ☒ **Debris** ☐ Grease

Silt Depth: **0** (in.) Deposits Extent: **Light**
